DuSable Park

**RIVER WALL CONDITION ASSESSMENT AND
PRELIMINARY REPAIR COST ESTIMATE FOR
PROPOSED DUSABLE PARK DEVELOPMENT**

UNDERWATER INVESTIGATION OF THE DUSABLE PARK DOCKWALL ALONG THE MAIN BRANCH OF THE CHICAGO RIVER IN CHICAGO, ILLINOIS

APRIL 2005

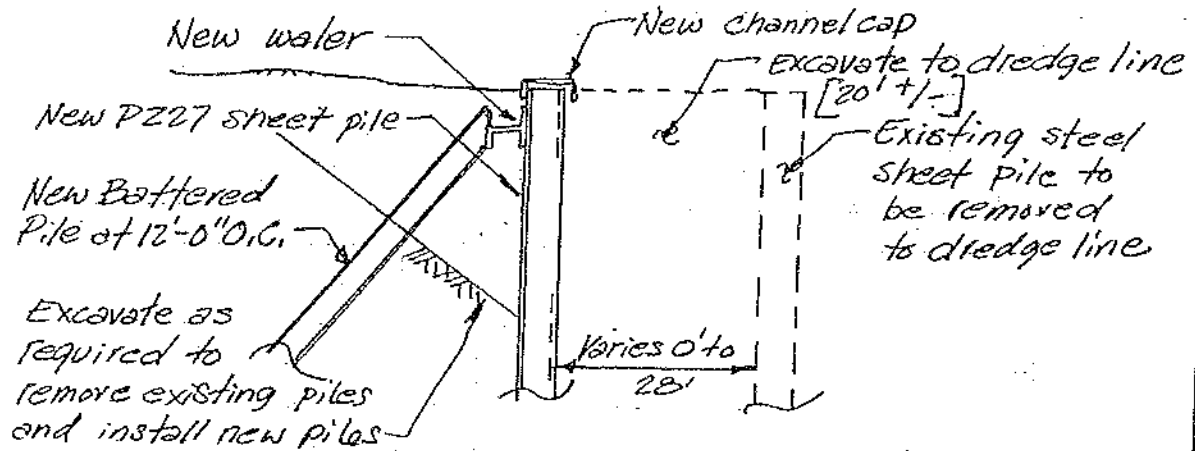
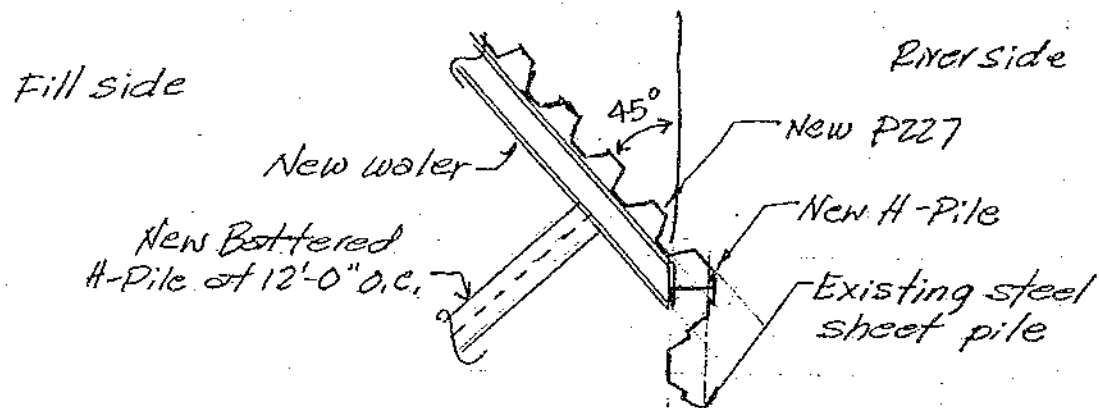
EXHIBIT 4
Southeast Corner Wall Replacement
Section and Detail

The south east corner of the site was the most difficult to inspect due to the presence of large timbers across the top of the wall. In addition, facing timbers on the riverside of the wall prevented the inspection of protruding tie rods and other features. These same conditions were reported in the 1997 inspection. It appears that the south and east portions of the wall comprising this corner may have undergone some lateral movement. It appears that a more substantial repair may be required in this vicinity. A suggested repair detail has been developed and is described in Section 5. It is hypothesized that a contributing factor to the deterioration of this portion of the wall is the non-uniform stress concentrations and 3-dimensional soil-structure interaction that takes place at a 90-degree corner.

The southeast corner of the property is in need of repairs. This portion of the wall is the most difficult to inspect because of the presence of large timbers. It is suggested that wall replacement be implemented at this corner. The approximate extent of the existing wall that requires replacement is 40 feet north and 40 feet west of the corner as shown on Exhibit 3. The proposed repair comprises the installation of a new wall and the demolition and removal of the existing wall. A section and detail of the proposed repair is shown on Exhibit 4. The repair detail comprises a new steel sheet pile wall, supported with batter piles as shown. At each end of the repair vertical H-piles are recommended to help tie the repair into the existing wall. A cost effective solution is to build a diagonal wall across the inside of the corner. Using this arrangement (and assuming that 40' x 40' corner is to be repaired) the replacement wall will be approximately 60 feet in length and will replace 80 feet of existing wall. This will result in the loss of about 800 square feet of the property (0.02 acres, less than 1%). Reconstruction of the existing corner with a diagonal wall is likely to be a preferable long-term solution and will better match the northeast corner as well as being about 20% cheaper than replacing the existing corner in-kind.

Proposed Repair for Southeast Corner
Typical Section

Proposed Repair for Southeast Corner
Typical End Detail

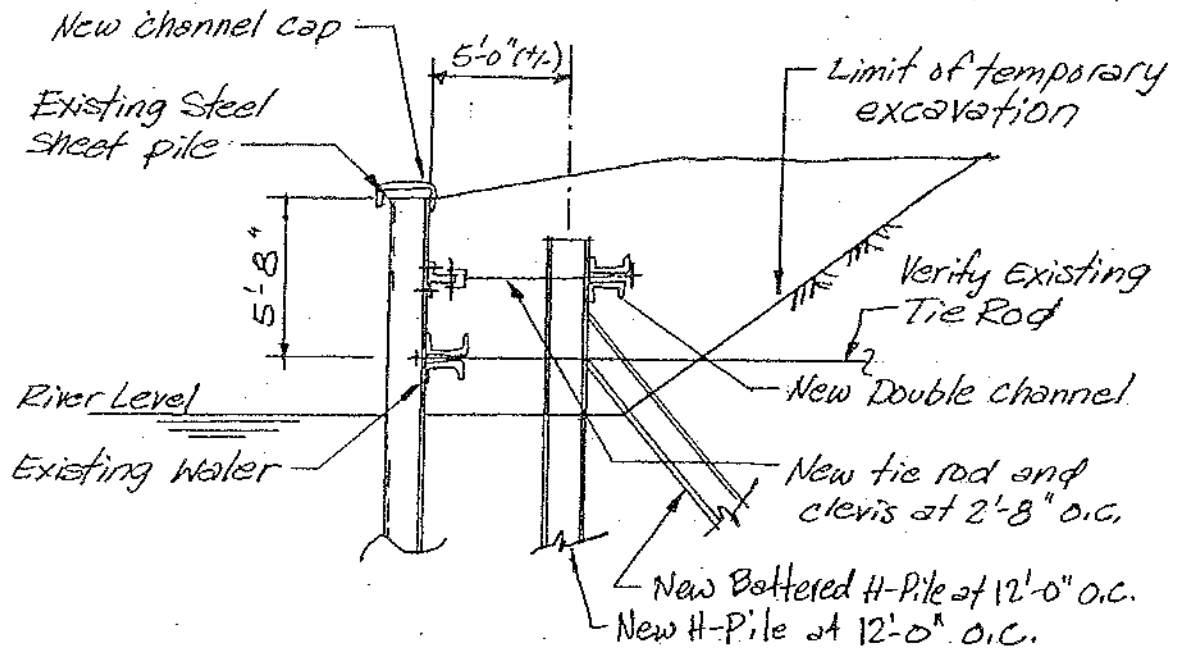
EXHIBIT 5**Proposed North Wall Stabilization Measures
Typical Section**

There is significant deterioration on portions of the north wall, including a section of wall that is bulging and several areas of pronounced corrosion. The conditions, as visible from the above ground inspection, do not appear to have worsened significantly from the time of the previous inspection. A suggested repair detail has been developed and is described in Section 5.

A portion of the north wall is bulging northwards towards Ogden Slip. This condition was reported in the 1997 inspection and does not appear to be deteriorating rapidly. A repair detail is shown on Exhibit 5. The proposed repair entails driving new supporting piles landward of the bulging section that would act to relieve some of the load on the wall and could bring it back into alignment. Prior to installing the supporting piles the area immediately behind the wall would be excavated to an elevation below the tie rods, and broken or missing tie rods could be replaced. The extent of the repair is estimated to be about 30 feet. The existing condition of the tie rods (presently buried and not visible) may require a larger portion of the wall to be repaired.

**Proposed Repair for North Wall
Typical Section**

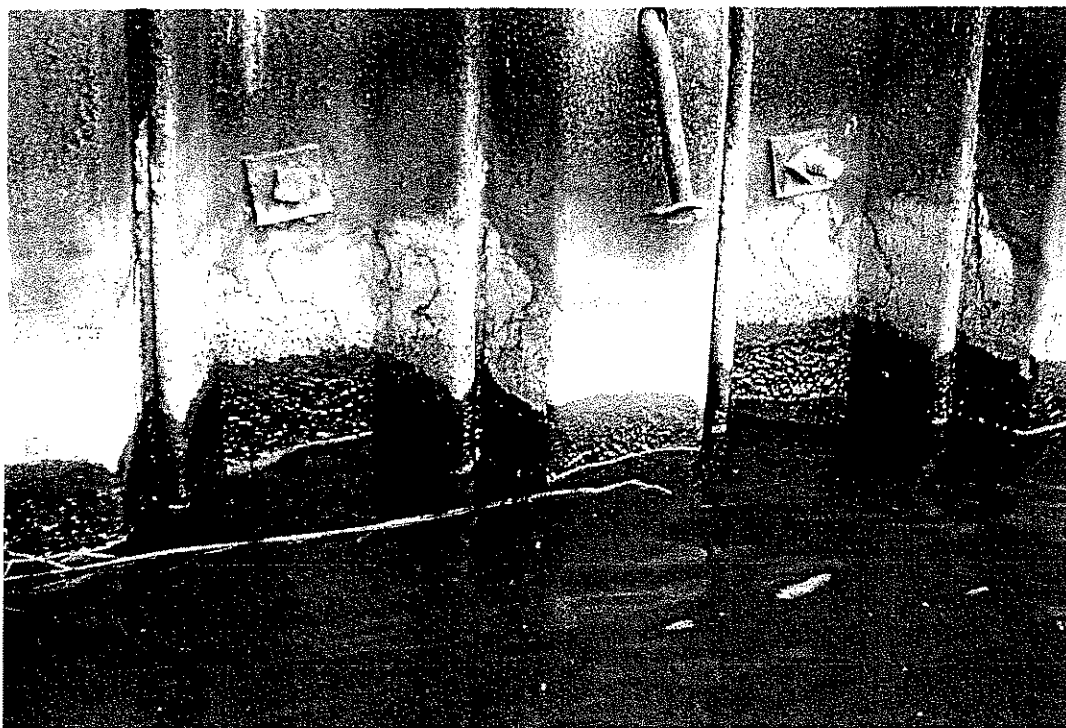
Photograph 6. View of Typical Steel Condition along Waterline at Station 0+75, Looking North.

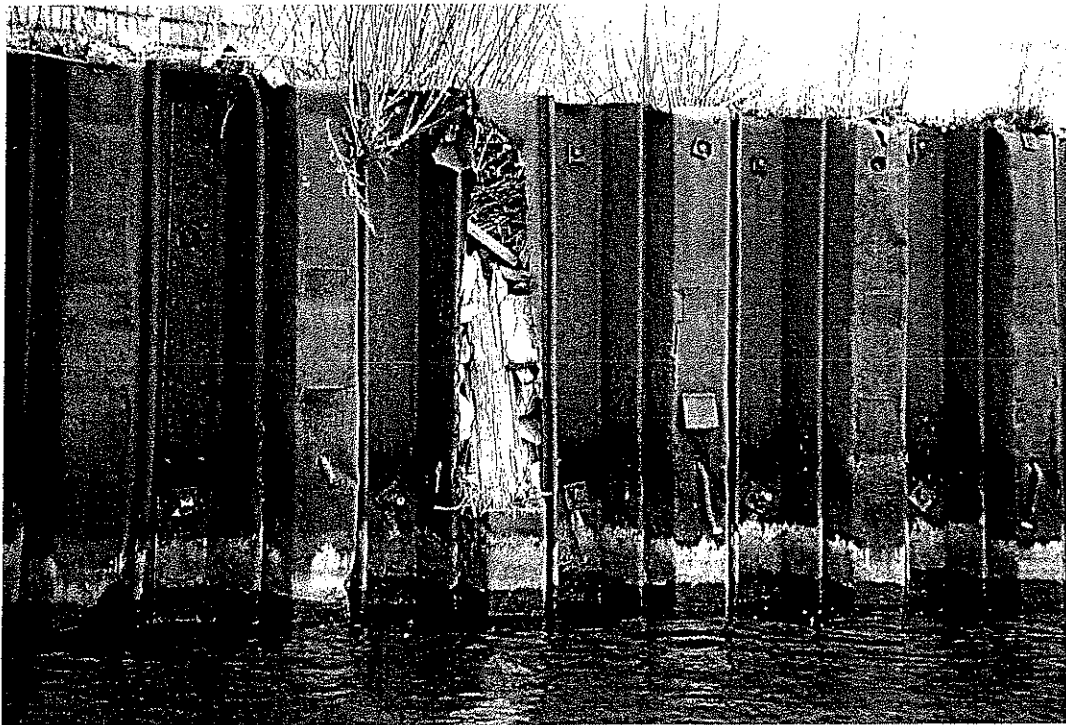
Photograph 8. View of Failed Sheet at Station 2+80, Looking North.

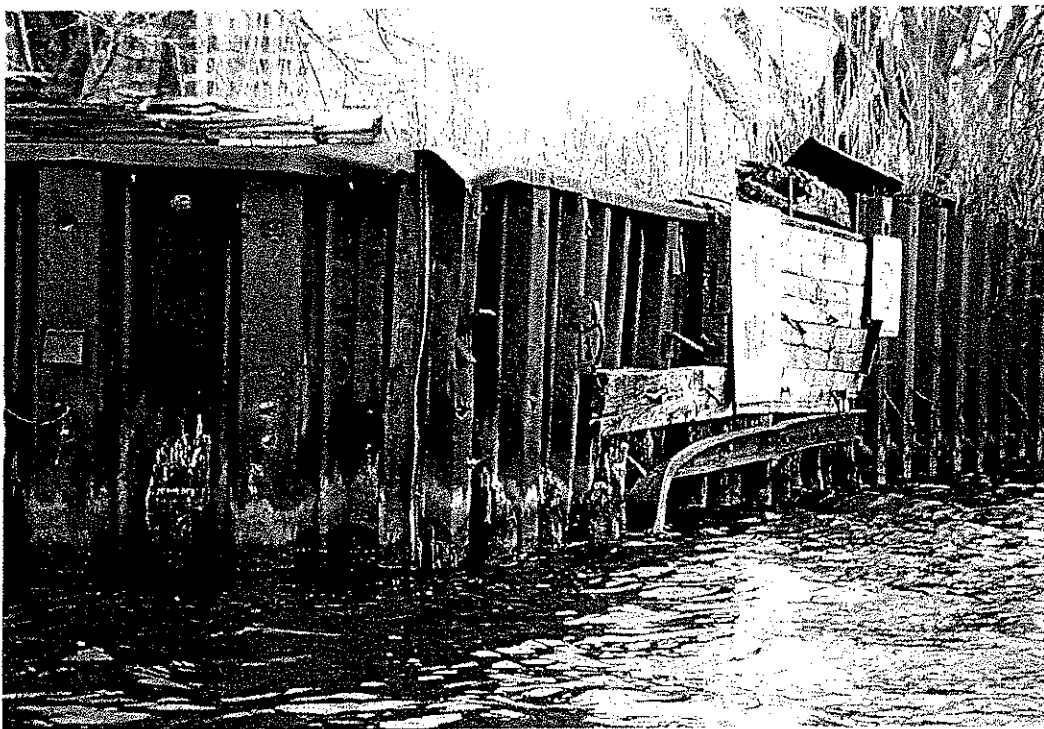
Photograph 10. View of Typical Steel Condition, Looking Northwest from Station 3+66.

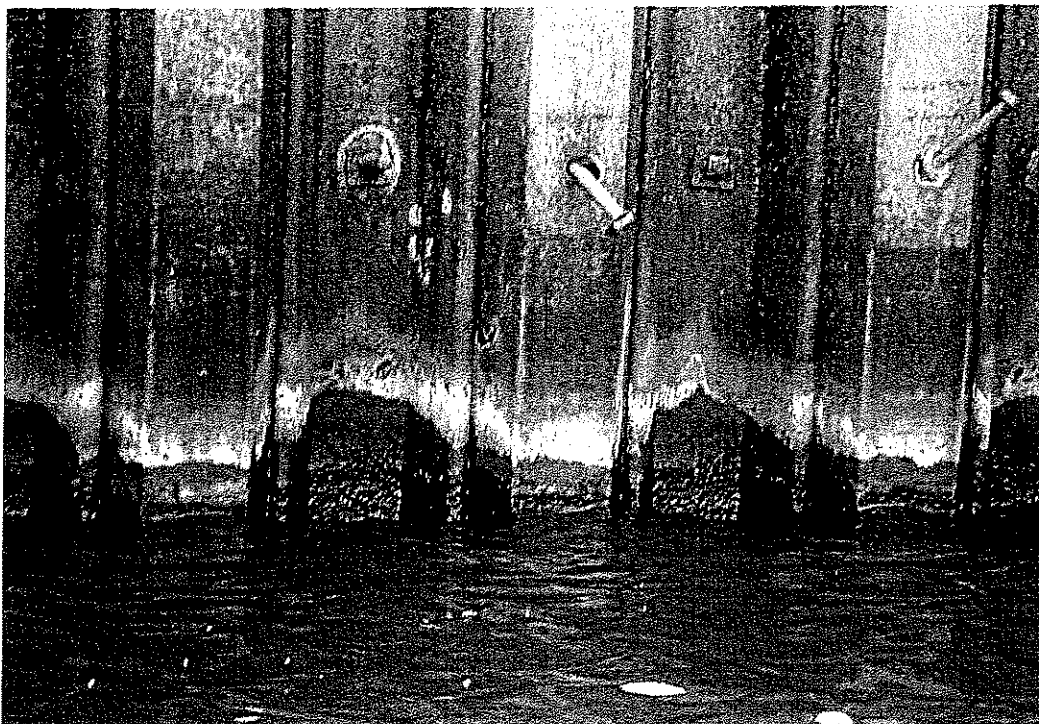
Photograph 11. View of Typical Steel Condition at Station 7+00, Looking West.

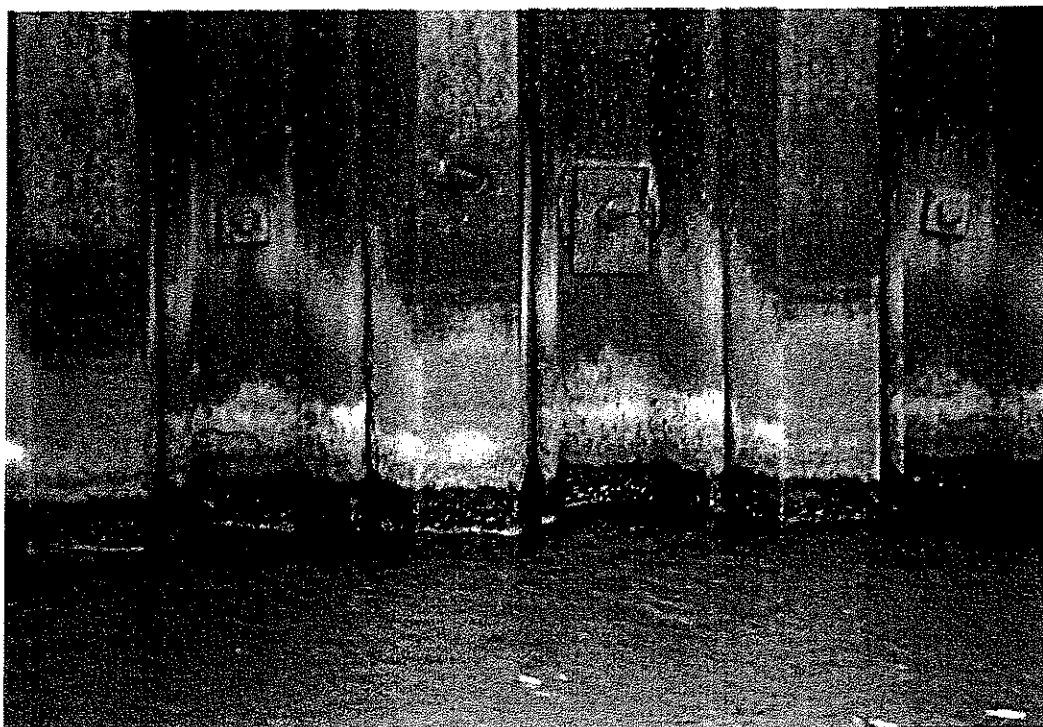
Photograph 12. View of Typical Steel Condition at Station 8+00, Looking West.

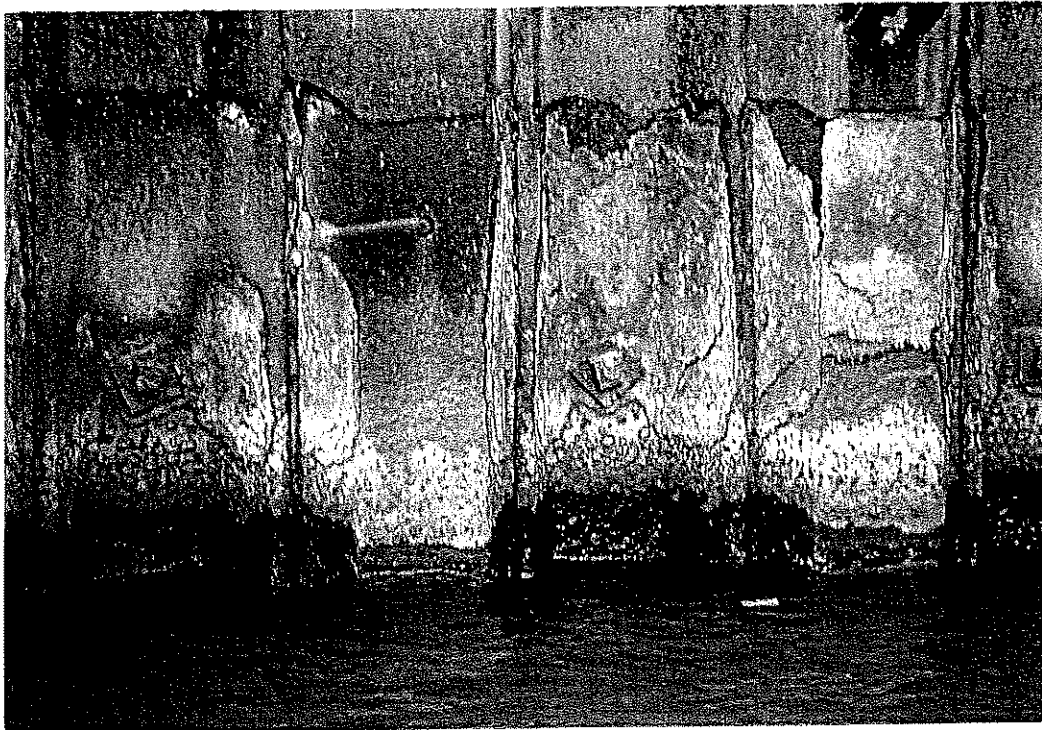
Photograph 13. View of Typical Steel Condition at Station 9+40, Looking South. Note Heavy Layer of Pack Rust and Steel Section Loss from the Waterline up 2 Feet.

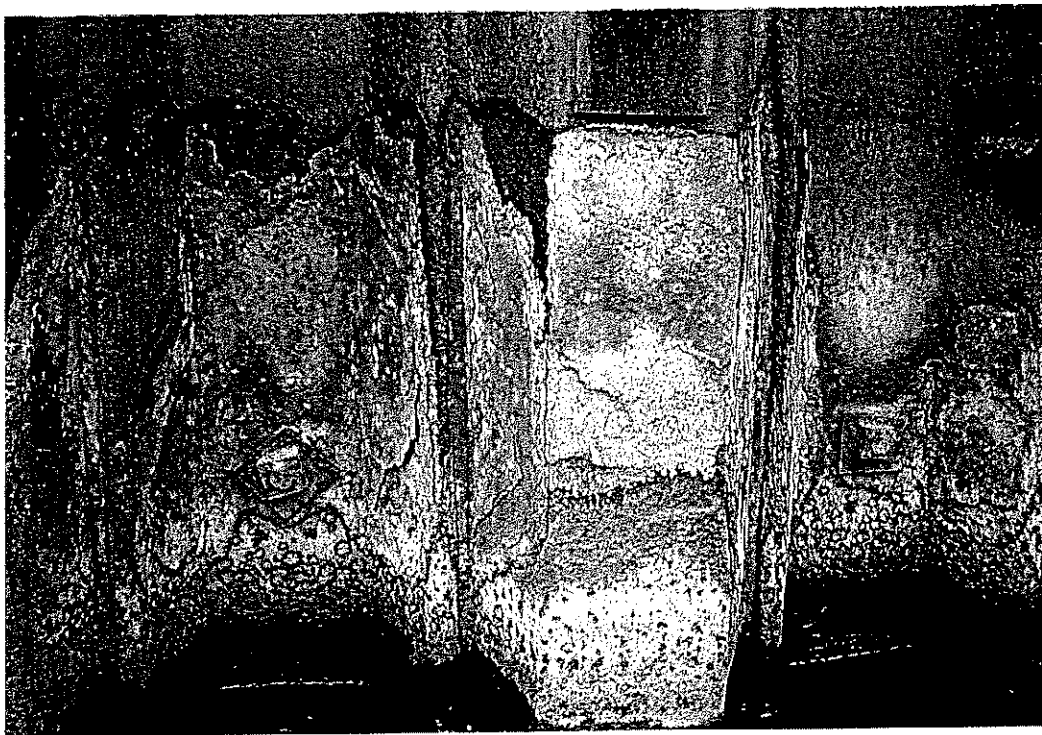
Photograph 14. View of Typical Steel Condition at Station 9+40, Looking South. Note Heavy Layer of Pack Rust and Steel Section Loss from the Waterline up 2 Feet.

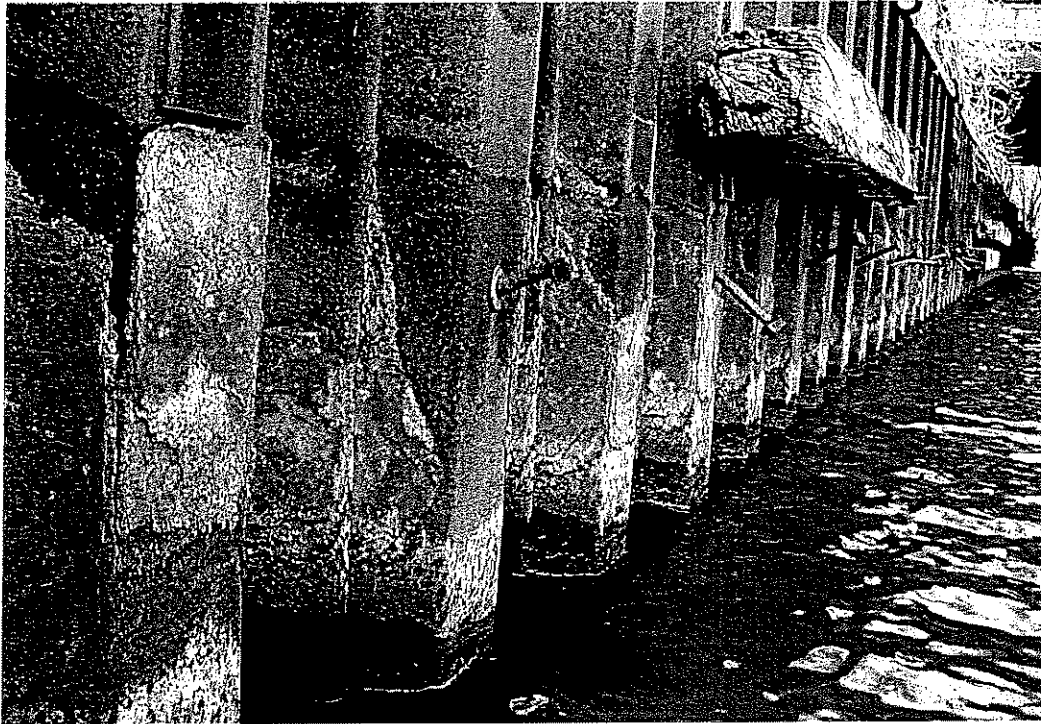
Photograph 15. View of Typical Steel Condition, Looking Southwest from Station 9+40.

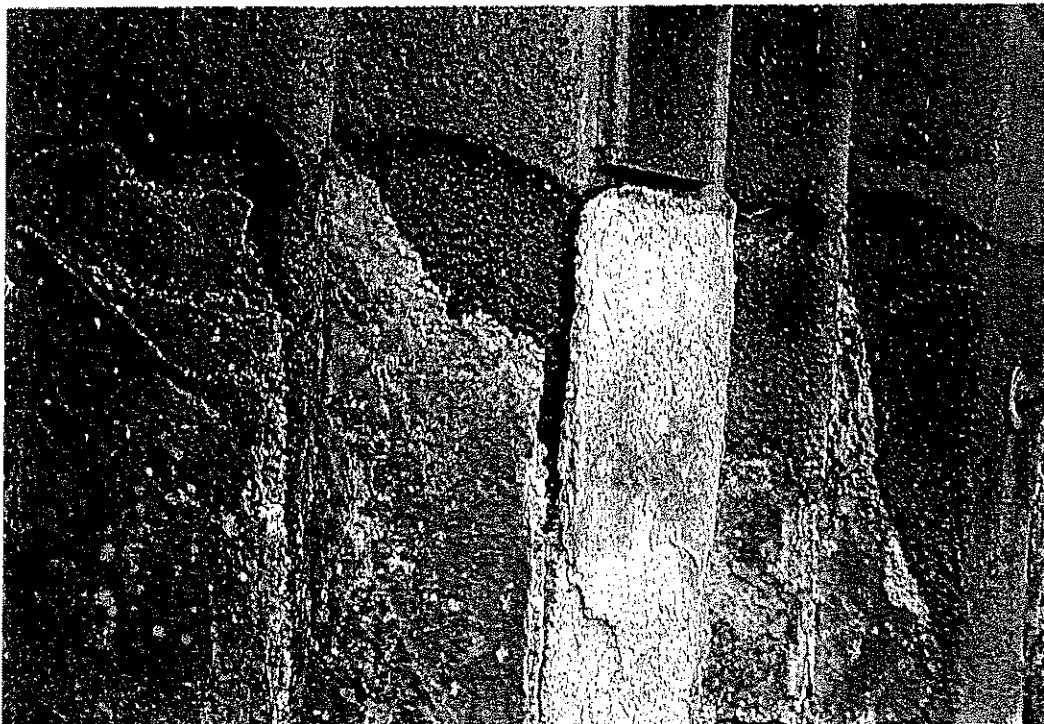
Photograph 16. View of Typical Steel Condition, Looking Southwest from Station 9+40. Note Heavy Steel Section Loss 2 Feet Above the Waterline.

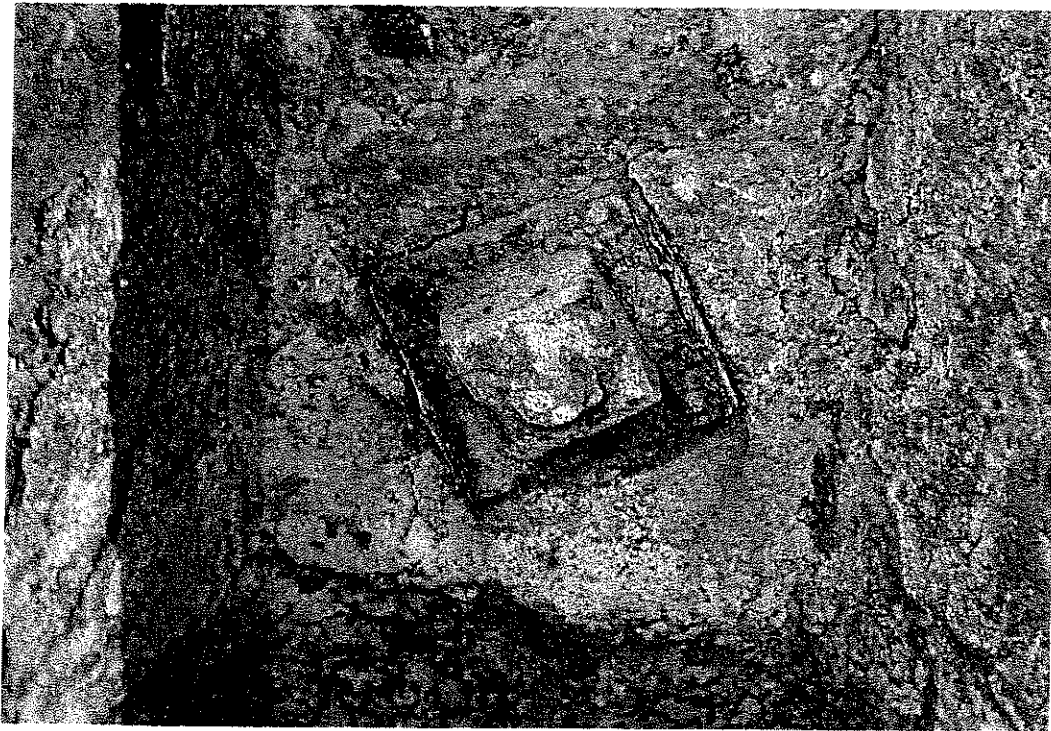
Photograph 17. View of Typical anchor Condition at Station 9+80, Looking South.

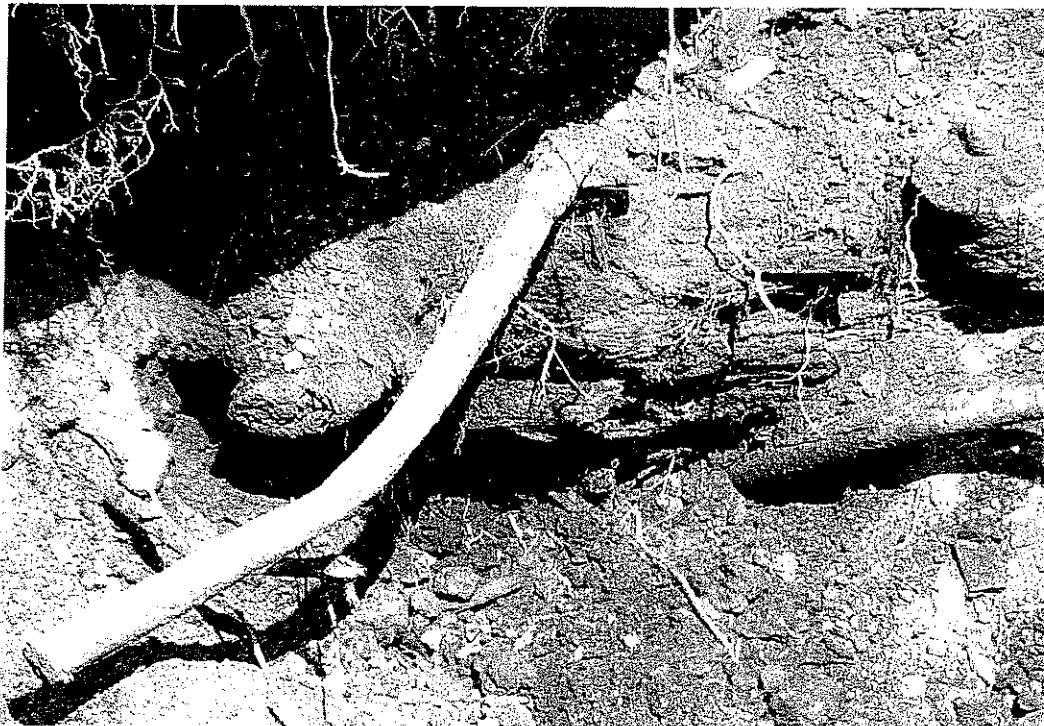
Photograph 21. View of Western Anchor Rod End at Station 3+94. Note Lack of Anchor Restraint System.
